# Accessibility Evaluation

## Monroe County Polling Location

**Souls Harbor Church**  
**7510 S Old State Rd 37**  
**Bloomington, IN 47403**

**Inspection Date: 03/16/2026**  
**Inspectors: Michael Bird**

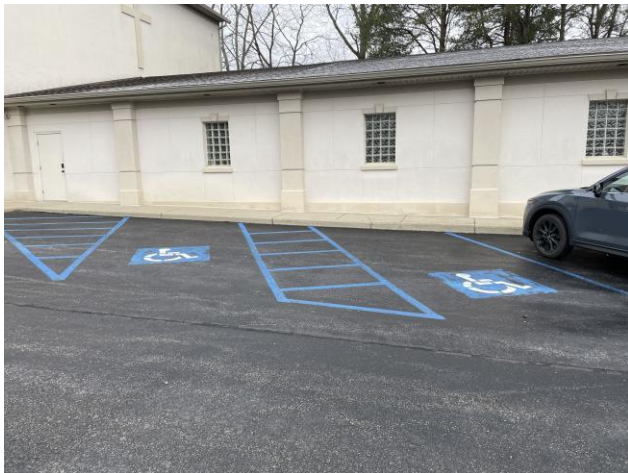
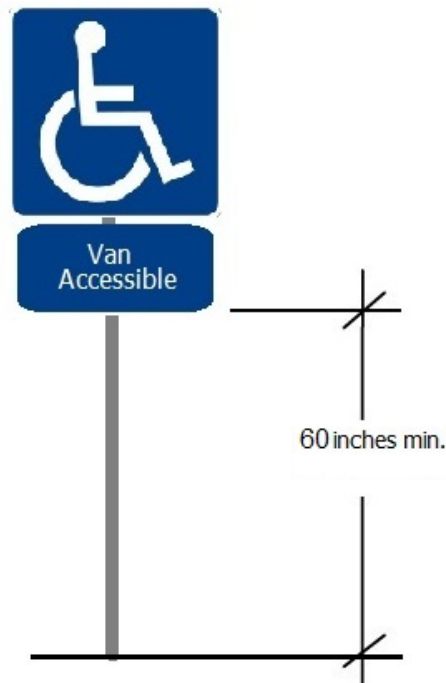
### Finding: 1

The required parking signage is missing.

Parking space identification signs shall include the International Symbol of Accessibility (ISA). Signs identifying van parking spaces shall contain the designation "van accessible." All signs shall be 60 inches minimum above the finish floor or ground surface measured to the bottom of the sign.

*2010 ADAS Section 502.6*

The four accessible spaces have no signage. Recommend adding temporary or permanent signs.

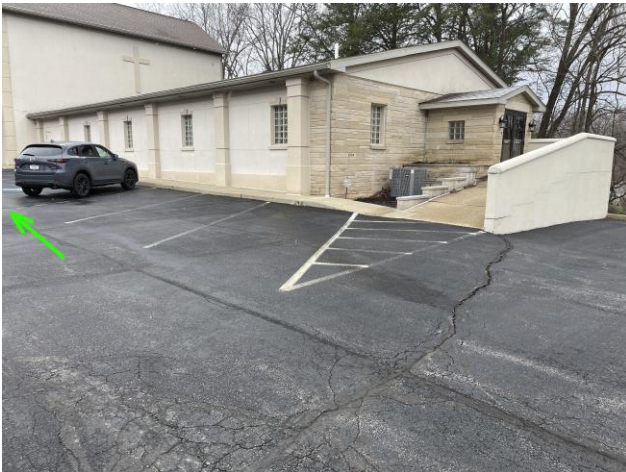
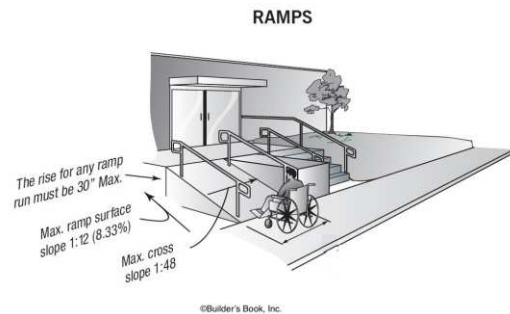
### Finding: 2

The ramps contains multiple issues.

The ramp contains running slopes greater than 8.3% and 2% cross slope.

The ramp does not have compliant level landings.

The ramp is not the required minimum width.

The ramp does not have compliant handrails with wheel guides.

The ramp surface contains changes in level.

*2010 ADAS Section 405.1*

The ramp has no railings and individuals must travel through the path of traffic to reach it. Recommend adding signage directing voters to the front doors as an alternate accessible entry.

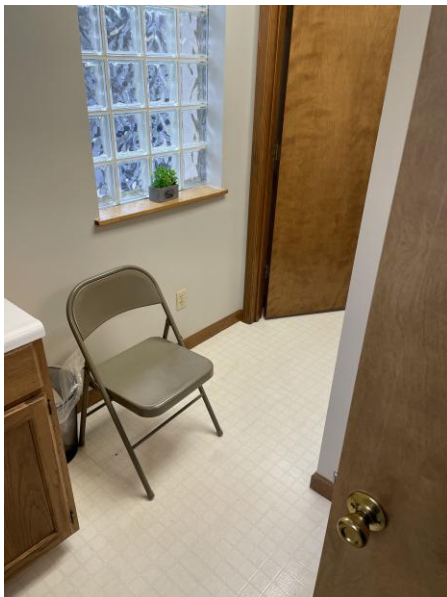
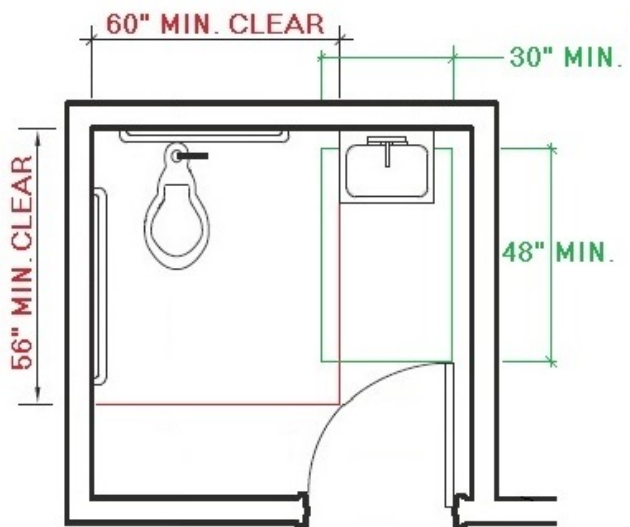
### Finding: 3

The restroom is not compliant.

The restroom may have some or all of the following problems: The restroom does not have the required minimum clear floor space or maneuvering clearances for the toilet. The restroom does not have the required minimum clear floor space or maneuvering clearances for the lavatory. The entry door does not contain the required minimum maneuvering spaces on the pull/push sides. The entry door encroaches into the required clear floor space for fixtures. Grab bars are missing and/or incorrectly installed. Accessories, such as toilet seat covers, paper towel holders, garbage cans, hand dryers, and mirrors are either too high or without clear floor space or both. The restroom contains floor level changes greater than a 1/2 inch of the floor drains and is slope (XX) - (XX), the shower is too small and missing numerous accessible elements.

2010 ADAS Section 213.2

Place signage informing voters that accessible restrooms are not available and directing voters with disabilities to the front of the line. Alternatively, place an accessible portable restroom outside.
